SERVICE NOTES

THE ARIEL SQUARE FOUR

JIM LEE, Ariel marque specialist, overhauls the unique four pot motor.

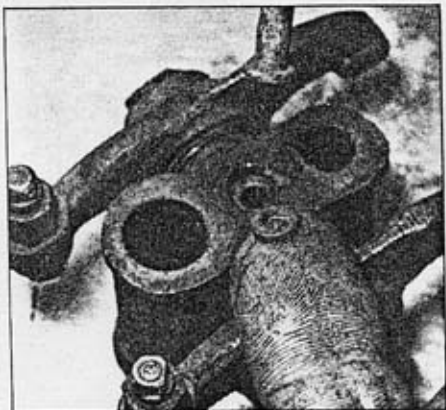
These small fibre washers must be fitted in recess in rocker pivot block to ensure oil tight joint for rocker spindle oil feed pipe.

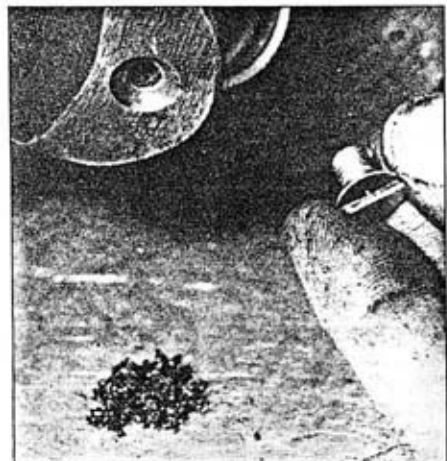
Typical of the amount of dirt that can be found in the crankshaft sludge traps.

The set screws are secured by centre punching and it is most important to remove them and clean out the hole right through the crank. With the screws removed, the dirt will be found to be

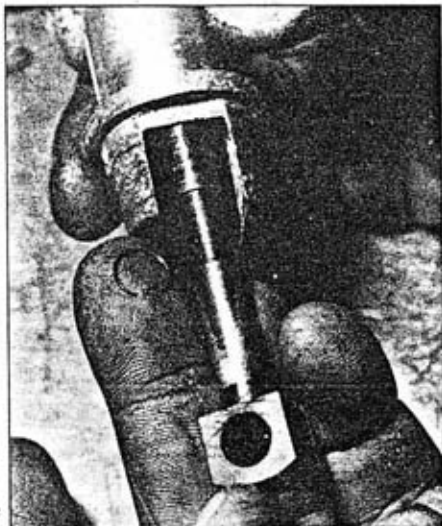
Cam followers run in alloy blocks secured to the base of the cylinder block by a locating plate, and two set bolts with lock washers.

cleaned, it is best to remove the tappet guides to prevent bead from being left in the engine by lodging around the guide block. The guides are removed by taking off the securing plates, which should be perfectly flat, and pulling free.

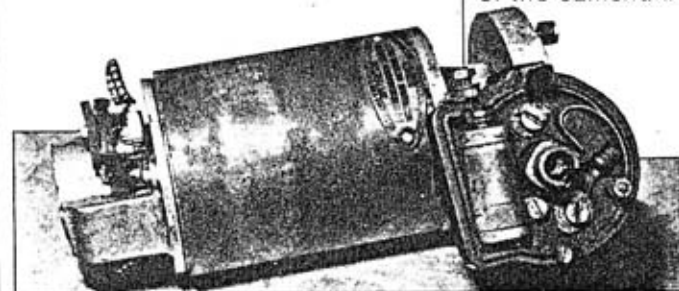
Lucas model C355D generator with distributor drive.
